2530 Murrell Rd
Santa Barbara CA 93109

1/16/2023

HouseMaster
1187 Coast Village Rd 1-284
Santa Barbara Ca 93108
(805) 898-2698

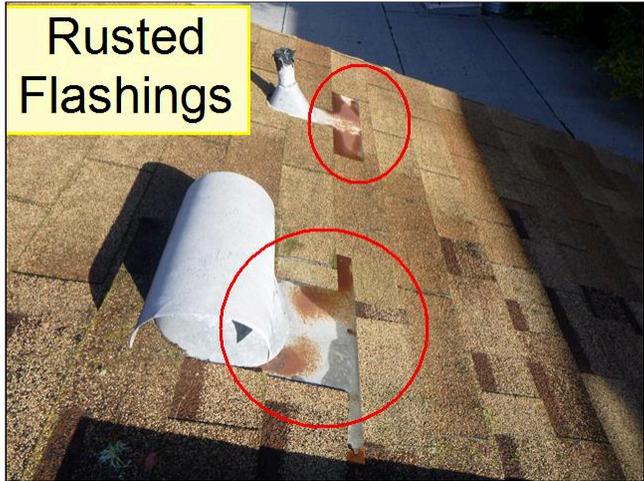
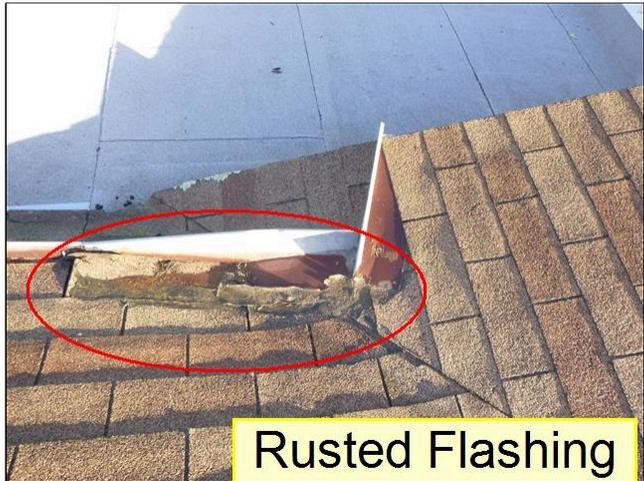
1.1 EXPOSED FLASHING (See Picture(s))

Rusting flashings noted. (See Picture(s)) Suggest painting to extend service life. Anticipate new flashing expense with new roof. (See Picture(s))

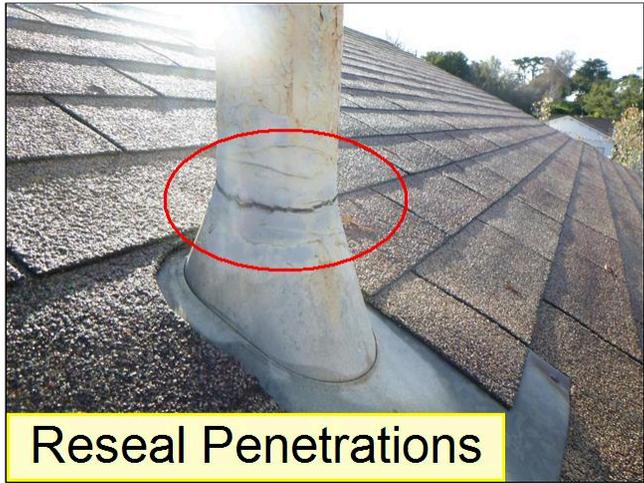
1.4 PLUMBING STACKS (See Picture(s))

Reseal Penetrations

Gaps noted at roof penetrations. Reseal roof penetrations now and on a routine basis to prevent leakage to interior of structure. (See Picture(s))

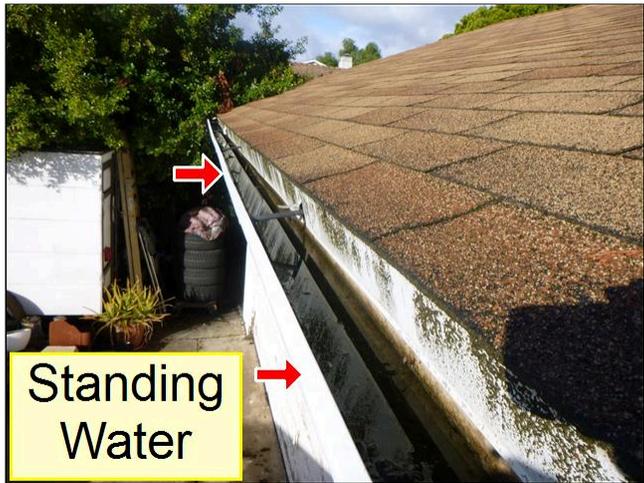
1.6 RAIN GUTTERS / EAVETROUGHES (See Picture(s))

Standing Water

Standing water noted in gutters. Ensure gutters are sloped properly to prevent standing water. (See Picture(s))

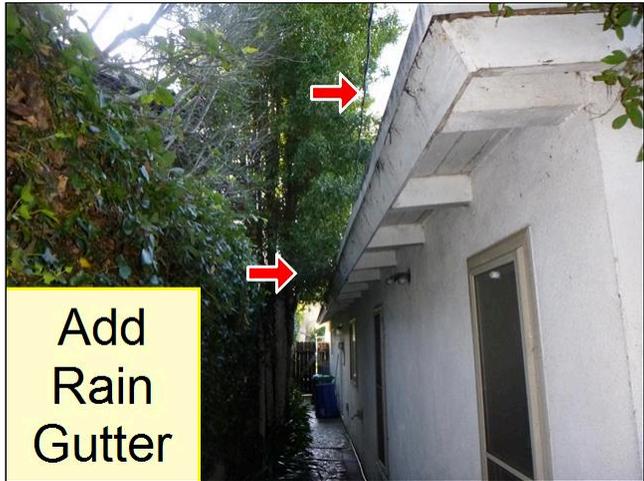
1.6 RAIN GUTTERS / EAVETROUGHES (See Picture(s))

Add Rain Gutter

Suggest adding more rain gutters and downspouts to aide in controlling water run off away from structure. (See Picture(s))

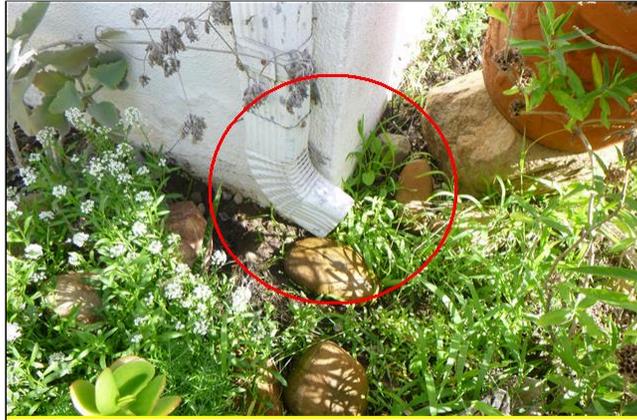
1.7 DOWNSPOUTS / ROOF DRAINS (See Picture(s))

Extend/Connect Downspouts

Recommend extending rain gutter downspouts to move water away from the foundation. Downspouts near structure may allow excessive water to pond and/or penetrate into structure. Consider installing downspouts into built in drains to aide in diverting water run off. See site elements section of report and supplemental comments for additional information. (See Picture(s))

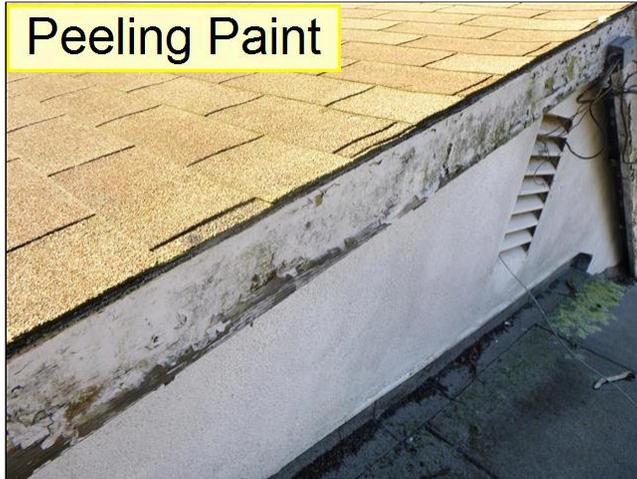
1.8 FASCIA / SOFFITS (See Picture(s))

Peeling Paint

Paint is peeling/loose at numerous locations. Due to the age of the home (1978 and older), the paint may contain lead. Suggest repainting to preserve wood. Use care when working with old materials, especially with paint. Have tested prior to disturbing. (See Picture(s))

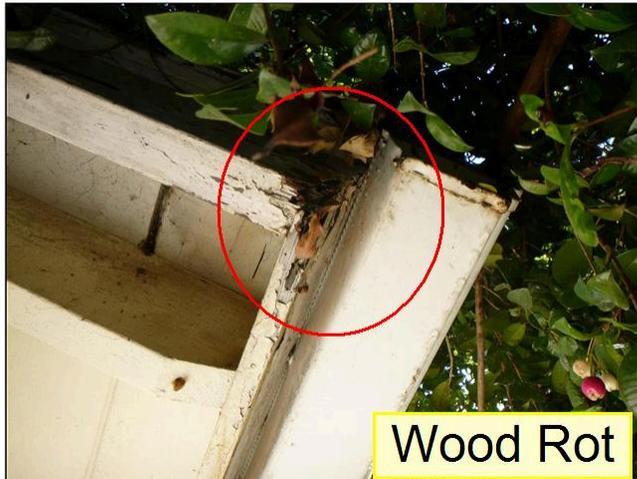
1.8 FASCIA / SOFFITS (See Picture(s))

Wood Rot

Wood damage/rot noted at fascia/eaves/soffit members. Anticipate repairs. See pest control company report for conditions and repair/treatment costs related to wood framing and trim members. (See Picture(s))

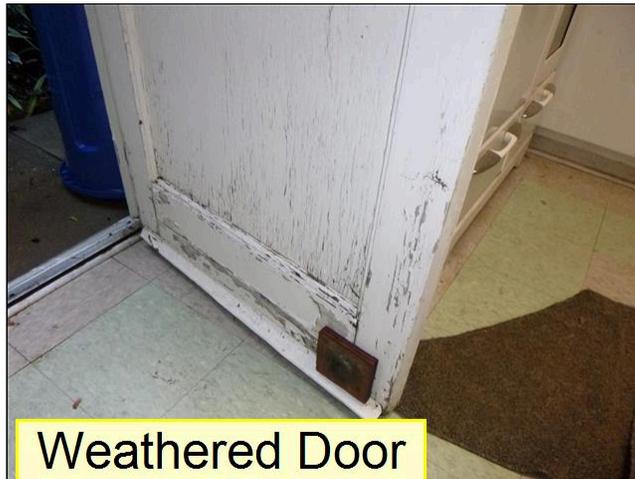
2.1 ENTRY DOORS (See Picture(s))

Weathered Door

Worn/weathered doors noted. Anticipate replacement. (See Picture(s))

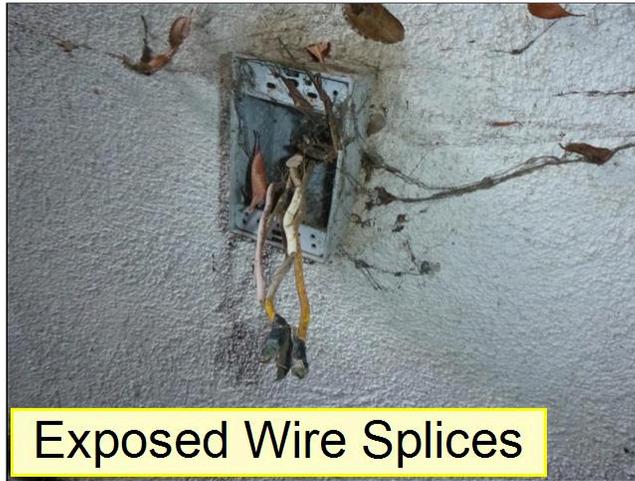
2.3 ELECTRIC / GFCI (See Picture(s))

Open junction box with exposed wiring noted at left side of house. Install an outlet or a cover plate for safety. (See Picture(s))

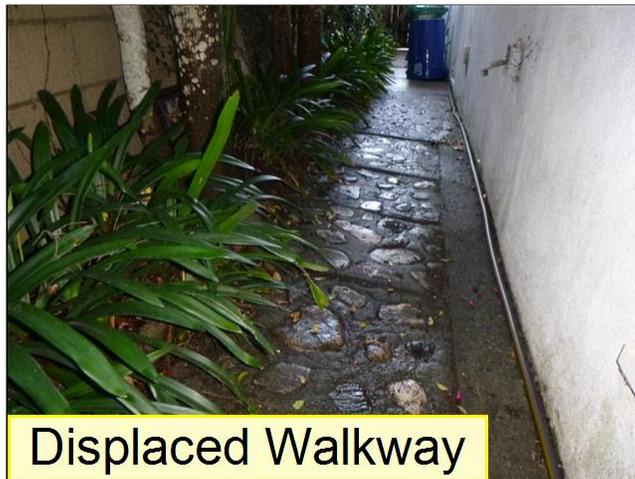
3.0 WALKWAYS (See Picture(s))

Unlevel surfaces with trip concerns noted. Suggest root removal and resetting for safety. (See Picture(s))

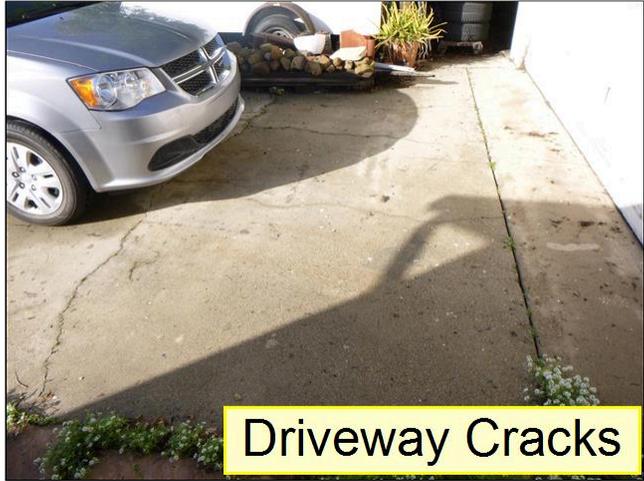
3.2 DRIVEWAY (See Picture(s))

Cracking noted at driveway. Anticipate repairs/sealing of cracks to prevent water penetration, further cracking and to extend service life. (See Picture(s))

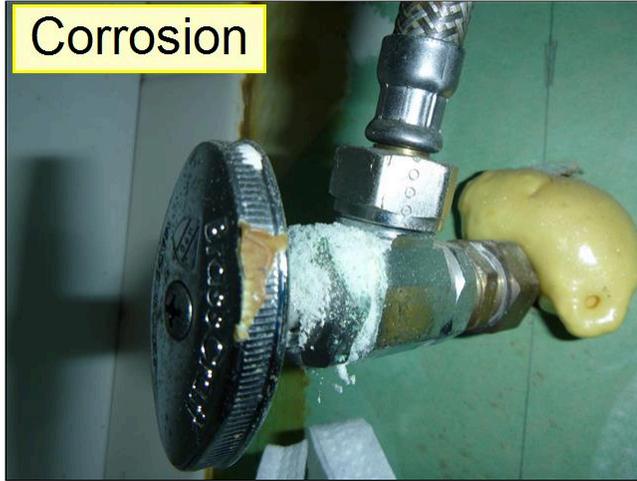
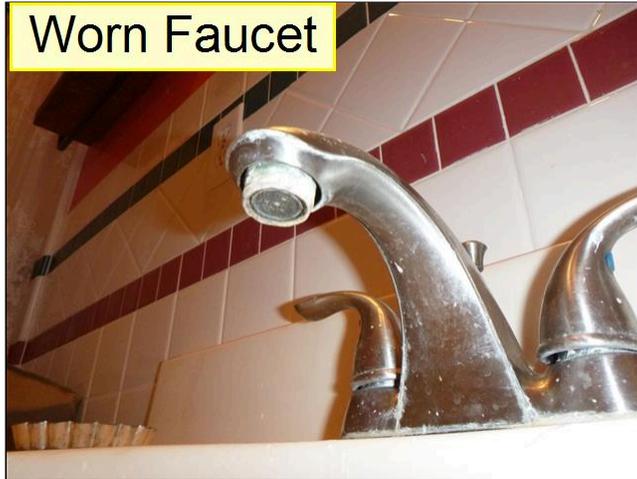
Corrosion

Worn Faucet

Older and worn faucets and vanities noted. Anticipate replacement. (See Picture(s))

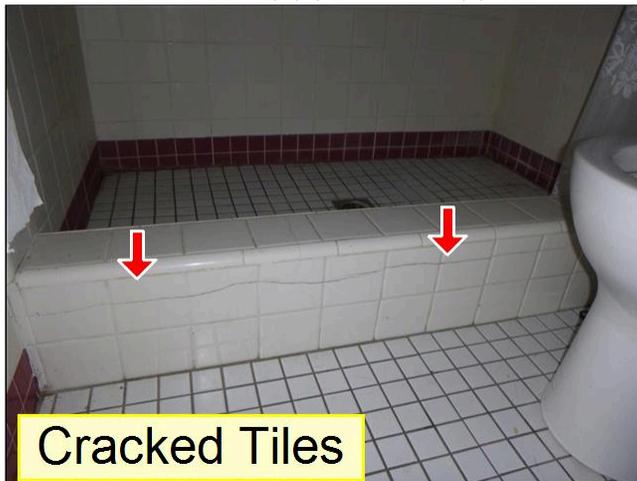
6.3 STALL SHOWER (See Picture(s))

Cracked Tiles

Cracked shower pan tiles and fixtures are older and worn. Anticipate repair/replacement. (See Picture(s))

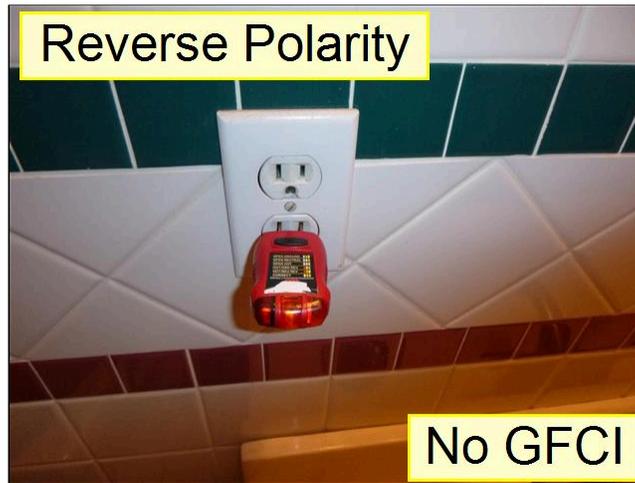
6.5 ELECTRIC / GFCI (See Picture(s))

Outlets in bathrooms should be protected by a Ground Fault Circuit Interrupter. Consult electrician for installation for added safety. Due to the age of original construction, this is considered an upgrade item. However, it is highly recommended for safety reasons.

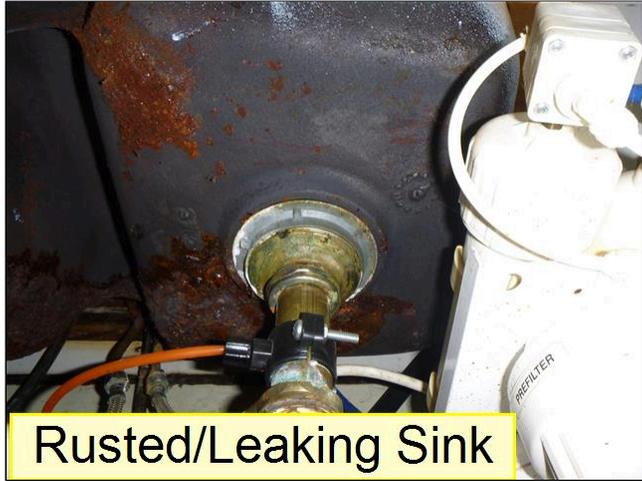
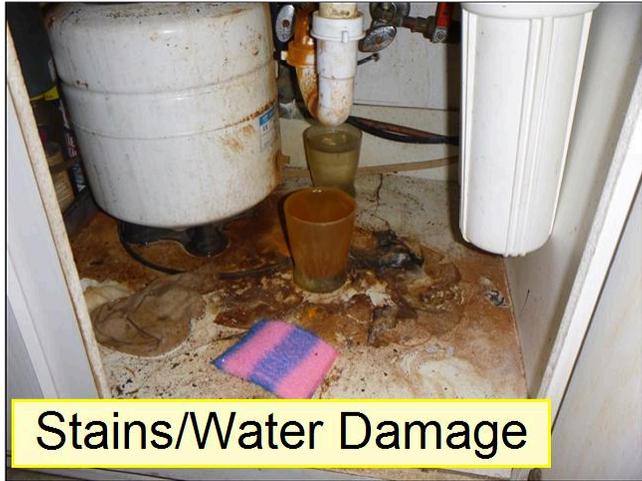
Rusted/Leaking Sink

Stains/Water Damage

Stains/moisture damage noted under kitchen sink. Unable to determine condition behind concealed areas. Look for/anticipate hidden damage/mold behind materials. (See Picture(s))

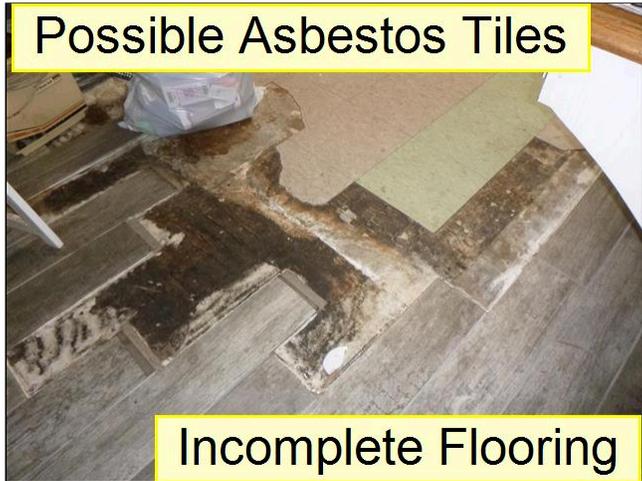
7.1 FLOOR(ING) (See Picture(s))

Possible Asbestos Tiles

Incomplete Flooring

Incomplete tile flooring install at kitchen with possible asbestos containing noted. Consult a flooring contractor for testing prior to disturbing.
(See Picture(s))

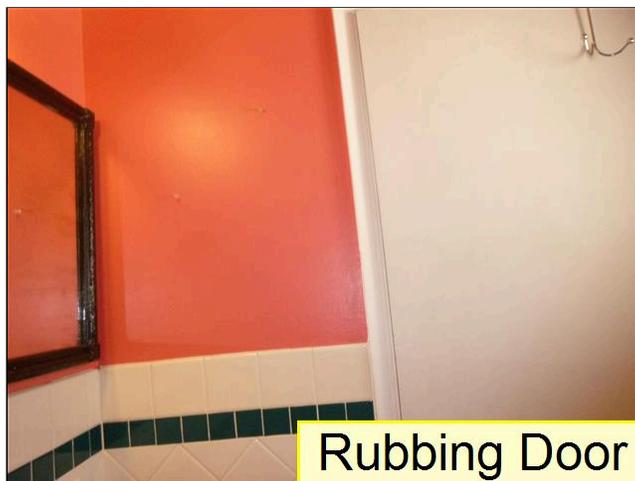
8.4 ROOM DOORS (See Picture(s))

Several rubbing doors noted. Trim/sand doors as required for proper clearance. (See Picture(s))

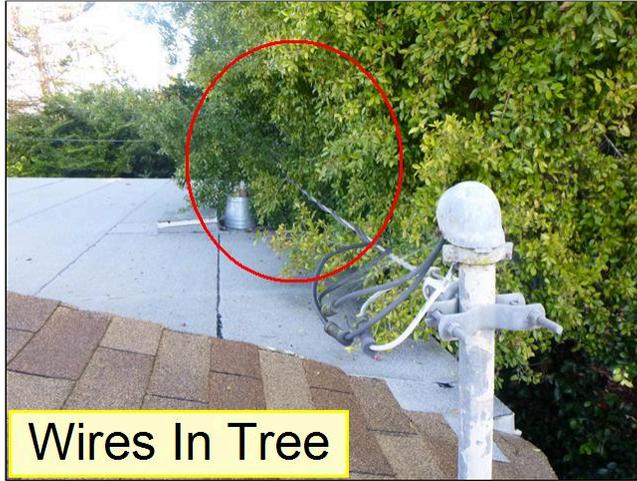
9.0 SERVICE / ENTRANCE LINE (See Picture(s))

Wires In Tree

Service wires are in trees and may be damaged by branches. Consult utility company to trim branches away from service wires to prevent damage. (See Picture(s))

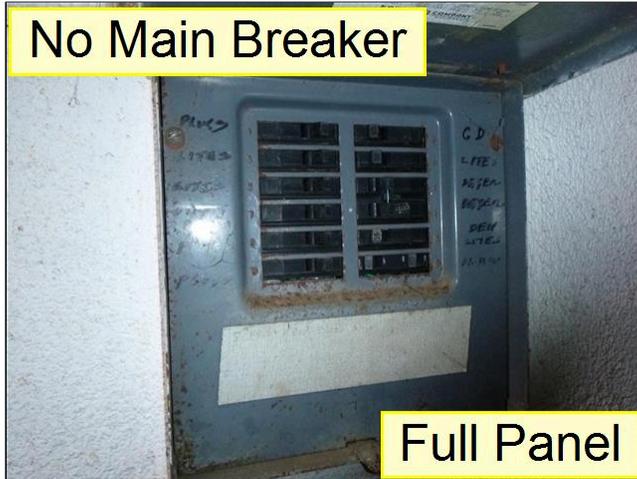
9.3 MAIN DISCONNECT(S) (See Picture(s))

No Main Breaker

Full Panel

More than six disconnects noted in panel. A single main disconnect should be installed per current safety standards. Consult an electrician for evaluation/options/cost. (See Picture(s))

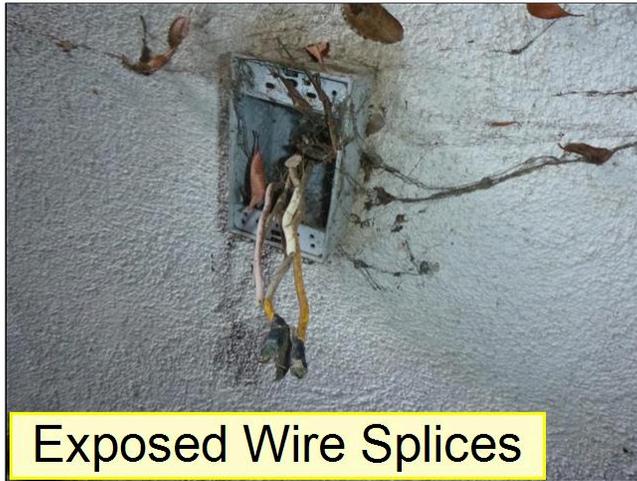
9.5 WIRING / CONDUCTORS (See Picture(s))

Exposed Wire Splices

Open junction box with exposed wiring noted at left side of house. Install an outlet or a cover plate for safety. (See Picture(s))

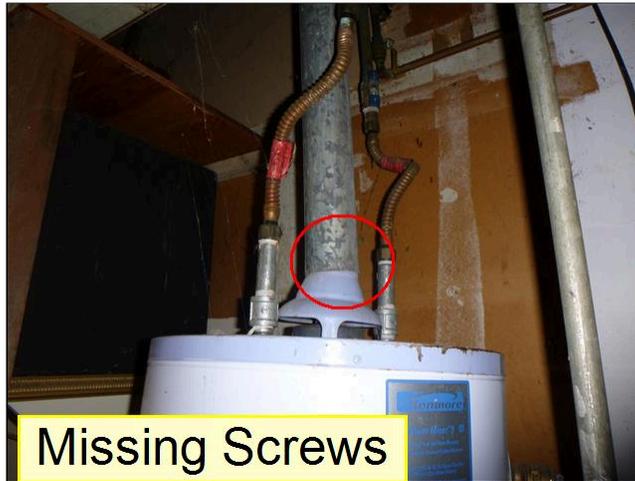
12.1 VENT CONNECTOR (See Picture(s))

Missing Screws

No screws installed at vent pipe. Add 3 screws to each joint to keep vent pipe connected properly, especially during seismic activity. Loose and/or damaged vent pipes pose a possible safety concern. Consult plumber for repair as required for occupant safety. (See Picture(s))

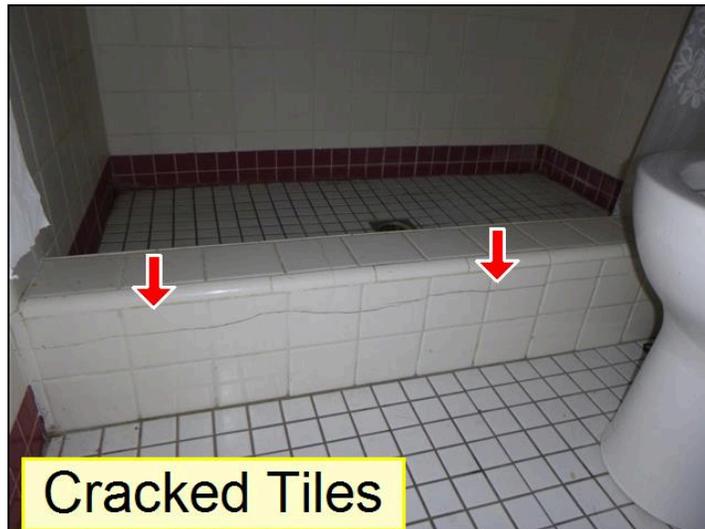
6.3 (See Picture(s))

Caulking/grout repair is needed now and recommended as part of routine maintenance at tub/shower and flooring areas on a regular basis to help prevent moisture intrusion, damage and mold build-up. Condition inside walls was indeterminate at the time of the inspection.

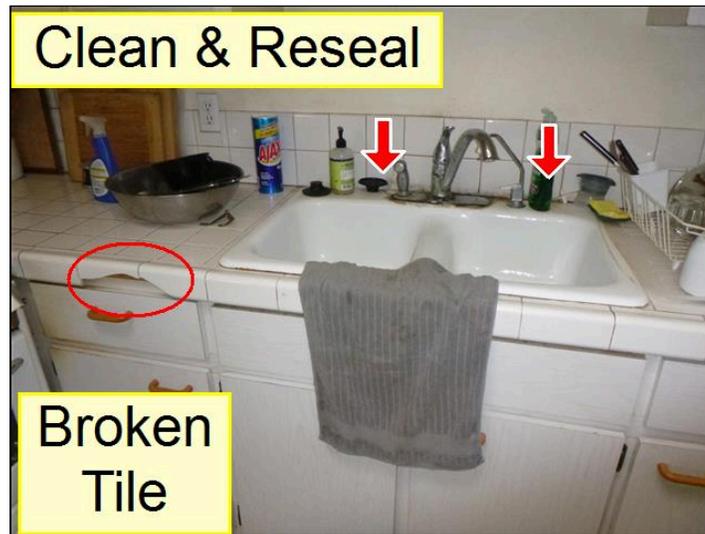
7.7 (See Picture(s))

Clean and re-seal gap at counter to backsplash joint to prevent water penetration behind materials.
