# WOOD DESTROYING PESTS AND ORGANISMS INSPECTION REPORT

| 2530 | Murrell Rd | Santa Barbara | 93109-1859 | 01/16/2023 | 1 of 7 |

| General Description:<br>Single family residence, slab foundation, stucco, 1 story, composition roof | Inspection Tag Posted:<br>Garage |

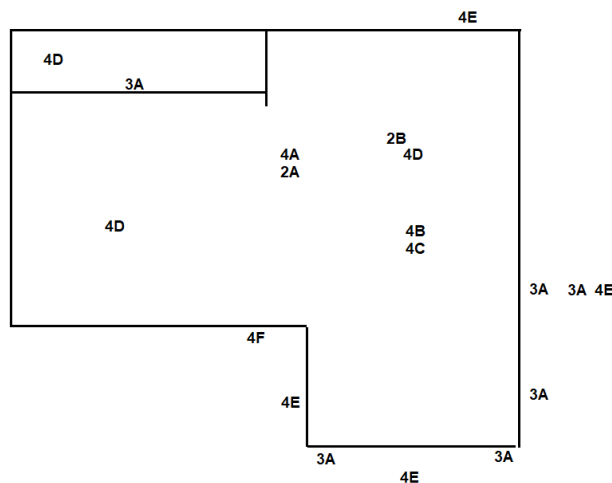
- Finding: 2A Evidence of Drywood Termites noted at attic as indicated on the diagram.  
Recommendation: Cover structure and fumigate for the elimination of Drywood Termites. Vikane will be used as the fumigant in combination with chloropicrin as a warning agent. Although we take every precaution, we cannot be responsible for damage to plants, paint, roofs and/or antennas. Fumigation cannot be performed during rains or heavy winds. THREE YEAR WARRANTY. NOTE: IF SWALLOWS NESTS ARE ACTIVE, FUMIGATION, BY LAW, MUST BE CANCELLED. ACCORDING TO THE DEPARTMENT OF FISH AND GAME, PREVENTION THROUGH EARLY DETECTION MAY BE THE BEST COURSE OF ACTION FOR HOMEOWNERS. IF THE MUD NESTS ARE DESTROYED BEFORE THEY ARE ONE-THIRD COMPLETE, NO LAWS ARE BROKEN. (At the end of three year warranty you may extend the warranty for \$300 or 15 percent of original fumigation cost per year. Cost includes full inspection and any spot treatments deemed necessary.)

Price: \$2,050.00
- Finding: 2B Drywood Termite damage noted at ceiling as indicated on the diagram.  
Recommendation: Repair or replace damaged wood as deemed necessary. Should damage extend into inaccessible areas, a Supplemental Report will be issued indicating our findings, recommendations and any additional costs for repairs.  
Price: Included in 3A

- Finding: 3A Fungus damaged wood noted at shiplap, rafter, fascia and door as indicated on the diagram.  
Recommendation: Repair or replace damaged wood as deemed necessary. Should damage extend into inaccessible areas, a Supplemental Report will be issued indicating our findings, recommendations and any additional costs for repairs.  
Price: \$6,500.00

- Finding: 4A Water stains noted at attic and garage as indicated on the diagram.  
Recommendation: Owner to employ a licensed contractor to inspect and repair as deemed necessary.  
Price: Others
- Finding: 4B Water damage noted at sink as indicated on the diagram.  
Recommendation: Owner to employ a licensed contractor to inspect and repair as deemed necessary.  
Price: Others
- Finding: 4C Plumbing leak noted at kitchen sink as indicated on the diagram.  
Recommendation: Owner to employ a licensed contractor to inspect and repair as deemed necessary.  
Price: Others
- Finding: 4D Water damage noted at ceiling as indicated on the diagram.

Finding: 4E Faulty grade noted at areas as indicated on the diagram.

Finding: 4F Water damage noted at siding as indicated on the diagram.

Recommendation: Owner to employ a licensed contractor to inspect and repair as deemed necessary.
