2530 Murrell Rd
Santa Barbara CA 93109

1/16/2023

HouseMaster
1187 Coast Village Rd 1-284
Santa Barbara Ca 93108
(805) 898-2698

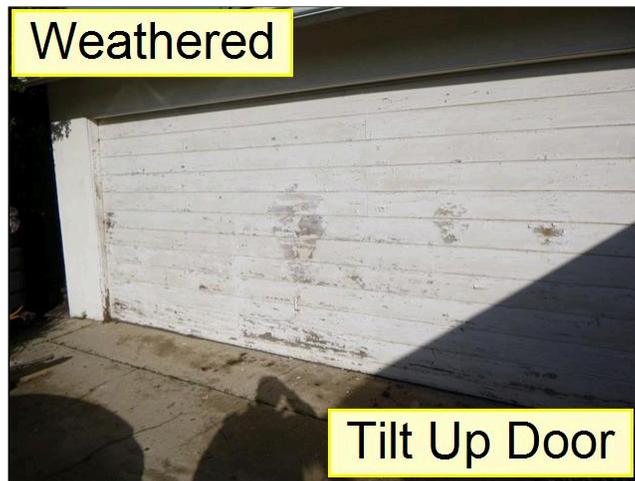
4.2 VEHICLE DOOR(S) (See Picture(s))

Weathered one piece wood tilt up garage door with worn hardware noted. Upgrade to a lighter roll up door would be beneficial. (See
